Manhole Inspection Summary

Manhole # S57E__023MH

Insp Date: **6/30/08 9:10 AM**

Location Address: **200 s haven st**

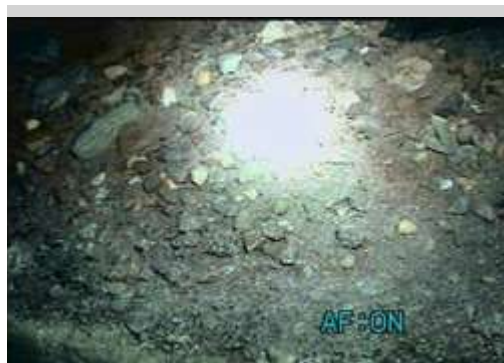
Defect 3

Condition: ☐ Sound ☐ Cracked ☐ Root Intrusion ☐ Deteriorated ☐ Leaks ☒ **Debris**

bench debris

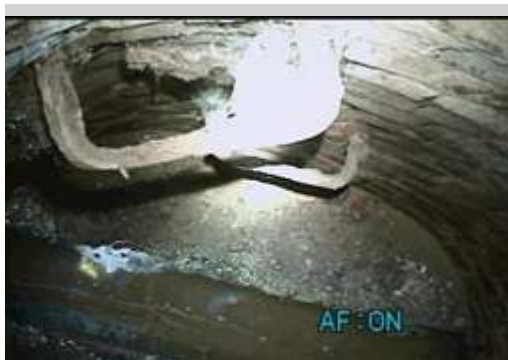
Defect 2

Steps Count: **3** Missing: **0** ☒ **Corroded**

steps

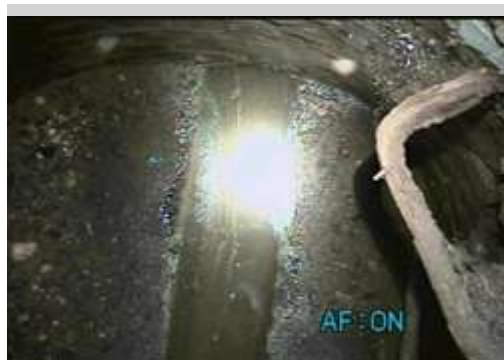
Defect 4

Condition: ☐ Sound ☐ Cracked ☐ Root Intrusion ☐ Deteriorated ☐ Leaks ☒ **Debris**

channel cond debris

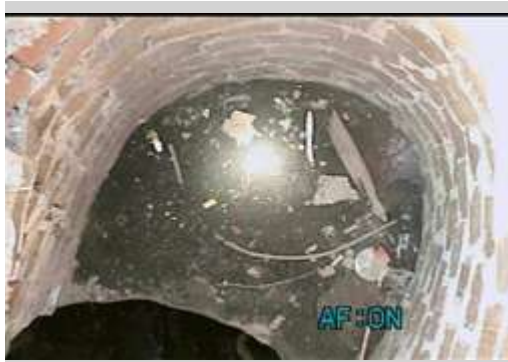
Defect 5

Condition: ☐ Sound ☒ **Cracked** ☐ Root Intrusion ☒ **Loose Brick** ☐ Deteriorated

Condition: ☐ Sound ☐ Cracked ☐ Root Intrusion ☒ **Loose Brick** ☐ Deteriorated

barrel cond and corbel cond defect

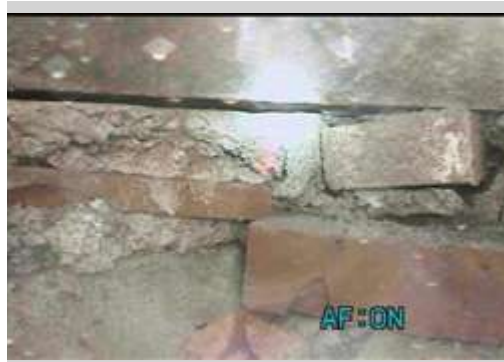
Defect 1

Condition: ☐ Sound ☒ **Cracked** ☐ Root Intrusion ☐ Loose Brick ☐ Deteriorated

frame adj

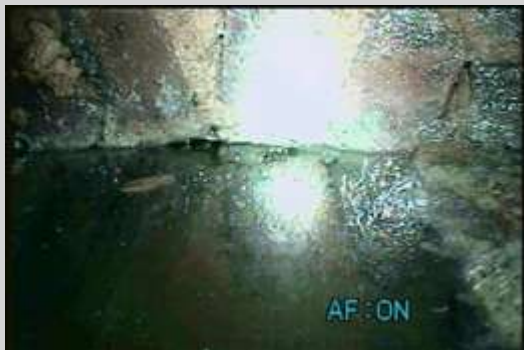
12 O'Clock Outflow

8 in. Circular Gravity Sewer
Pipe Out @ 12 O'Clock

Deposits: ☐ None ☐ Mud ☐ Sludge ☒ **Debris** ☐ Grease

Silt Depth: 8 (in.) Deposits Extent: **Heavy**
